Restoration of dynamic flood plain topography and riparian vegetation establishment through engineered levee breaching

JEFFREY F. MOUNT, JOAN L. FLORSHEIM & WENDY B. TROWBRIDGE

Center for Integrated Watershed Science and Management, University of California, Davis, California 95616, USA

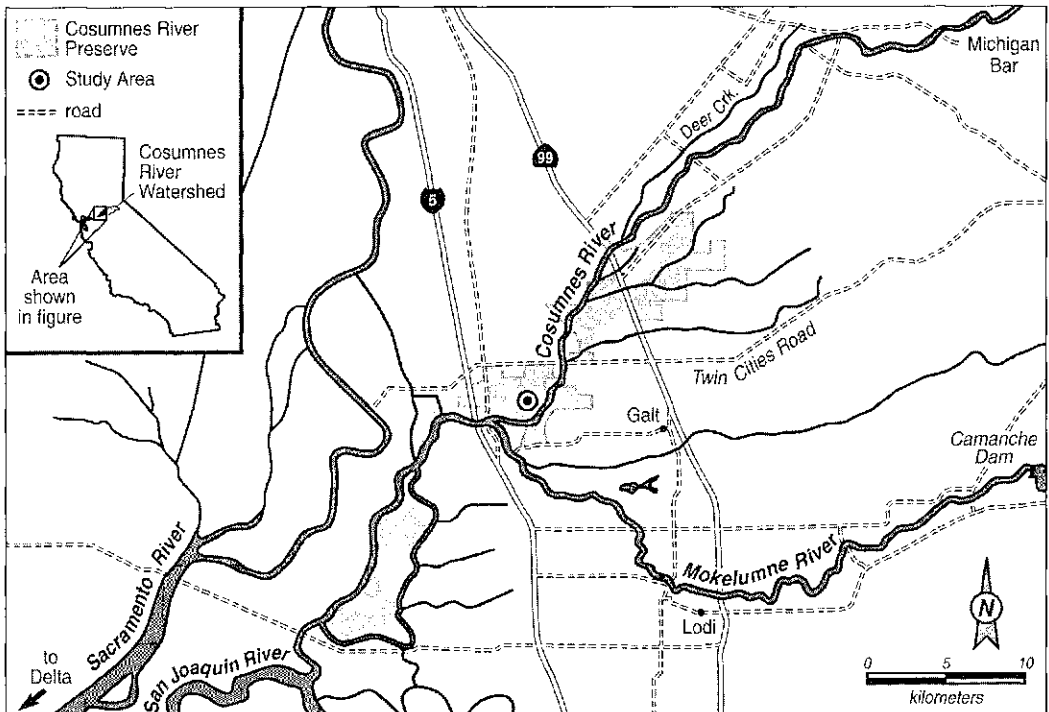
Fig. 1 Lower Cosumnes River study area from Michigan Bar to the San Francisco Bay–Delta denoting levee breach study area.

In this paper we report on the use of engineered levee breaches to restore hydraulic connectivity and dynamic flood plain topography within an experimental restoration site on the Cosumnes River in the Central Valley, California, USA (Fig. 1). This work demonstrates the utility of engineered breaches in mimicking processes typically associated with avulsion and the formation of crevasse splays at natural levee breaches in anabranching rivers.

The Cosumnes River basin (3000 km²) drains the western slope of the Sierra Nevada in California. The extensive flood plains of the lower Cosumnes occur in the Central Valley, just upstream of the San Francisco Bay–Delta (Fig. 1). Prior to the arrival of European settlers in the mid–late 1800s, the lower Cosumnes River occupied a broad, low-energy cohesive flood plain with low-gradient, anastomosing channels (Florsheim & Mount, 2002). The river and flood plain supported a mosaic of successional cottonwood–willow (*Populus fremonti* and *Salix* sp.) riparian forests, climax oak forests (*Quercus lobata*), and emergent wetland communities.

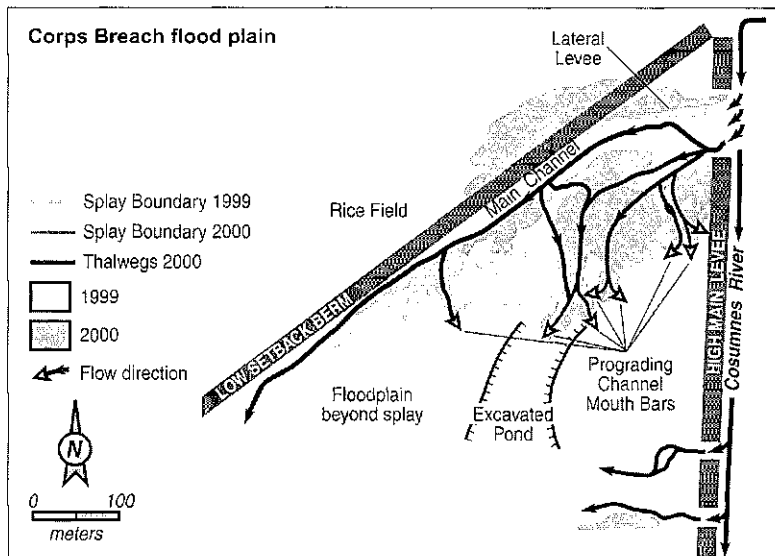
Fig. 2 Generalized geomorphic map of the Corps Breach constructed during fall of 1997. Note complex morphology and growth patterns of sand splay complex due to set back levee (modified from Florsheim & Mount, 2002).

The Nature Conservancy (TNC), along with its partners in the Cosumnes River Preserve, are conducting an extensive management and restoration programme in the lower Cosumnes River that focuses on wildlife-friendly agriculture and restoration of riparian, flood plain and wetland habitats (Andrews, 1999; TNC, 2000). Based on observations of successful establishment of riparian forests on sand splay deposits formed by historic levee failures, the Preserve partners experimented with intentional levee breaching in two locations: the Accidental Forest Breach, constructed October 1995, and the Corps Breach, constructed October 1997. Both breaches discharge water and sediment onto former agricultural fields that were graded and levelled prior to restoration. At the Corps Breach, a low set-back berm that deflects flows away from adjoining rice fields, and an excavated 2-m-deep “wildlife pond” were graded as part of the restoration project (Fig. 2).

At the two study areas, elongate sand splay complexes are developing adjacent to and down-flood plain from the breach openings (Figs 2, 3). The two complexes differ in geometry, thickness and complexity, reflecting differences in initial grading of the restoration sites prior to breaching. Both complexes are accumulating significant volumes of sediment, extending as much as 0.5 km down-flood plain from the breach.

Lateral levees/depositional lobes The most significant vertical accretion that occurs in sand splay complexes takes place on lateral levees that form adjacent to the main distributary channel and the breach scour (Figs 2, 3). The levees are formed through turbulent diffusion of sand in secondary flow cells of the main distributary channel into the flow separation eddies that flank the breach opening. The construction of the lateral levees creates the maximum elevations within the splay complexes and, as is shown below, plays a key role in the establishment and growth of riparian vegetation. The lateral levees of the splay complex are separated into depositional lobes incised by distributary channels. The lobes have highly irregular topographic surfaces that are extensively modified by small overwash channels and by high velocity flows that exceed distributary channel capacity.
